Manhole Inspection Summary

Manhole # S55G__023MH

Insp Date: **4/22/08 11:42 AM**

Location Address: **310 south conkling street**

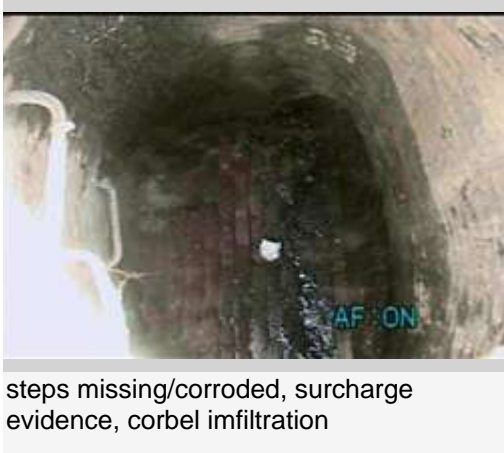
Defect 1

Infiltration: ☐ None ☐ Joint ☐ Cracks ☐ Mortar ☐ Roots ☒ Wall

Steps Count: **9** Missing: **4** ☒ Corroded

Surcharge ☒ Evidence Of Surcharge Depth: **3** (ft.) ☐ Active Surcharge Present

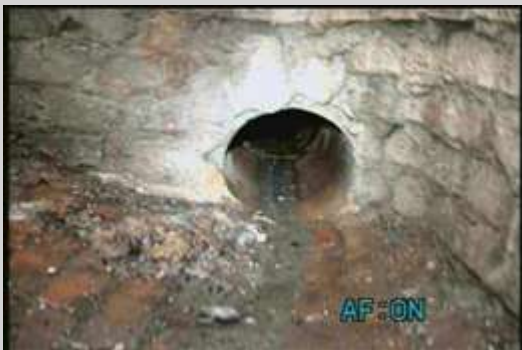
12 O'Clock Outflow

8 in. Circular Gravity Sewer
Pipe Out @ 12 O'Clock

Invert Depth: 7.30 (ft.) Flow Characteristics: Slow

Infiltration: None Pipe Seal Cond: Unknown

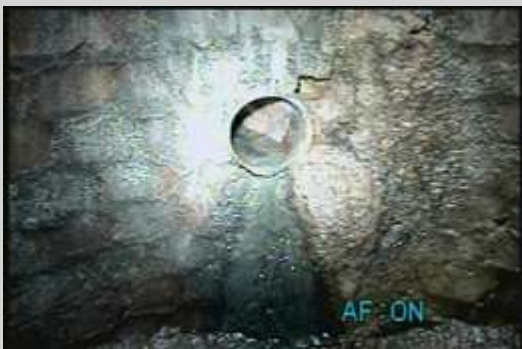
6 O'Clock Inflow

4 in. Circular Gravity Sewer
Pipe In @ 6 O'Clock

Invert Depth: 5.60 (ft.) Flow Characteristics: Slow

Infiltration: None Pipe Seal Cond: Unknown

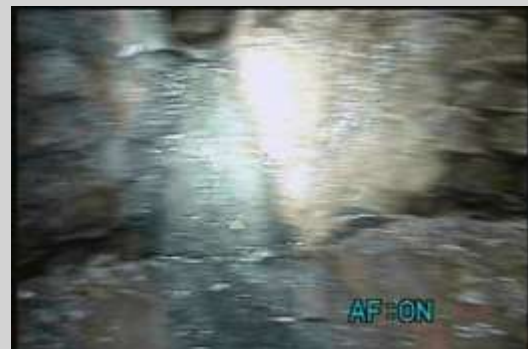
Drop In @ 6 O'Clock

Drop: Outside Direct

Inv Depth: 5.80 (ft.)

Drop Condition: Open

Connects To: House connection / Service line
